Debris/Ice/TPS Assessment And Photographic Analysis For Shuttle Mission STS-38

February 1991

DEBRIS/ICE/TPS ASSESSMENT
AND
PHOTOGRAPHIC ANALYSIS
OF
SHUTTLE MISSION STS-38

November 15, 1990

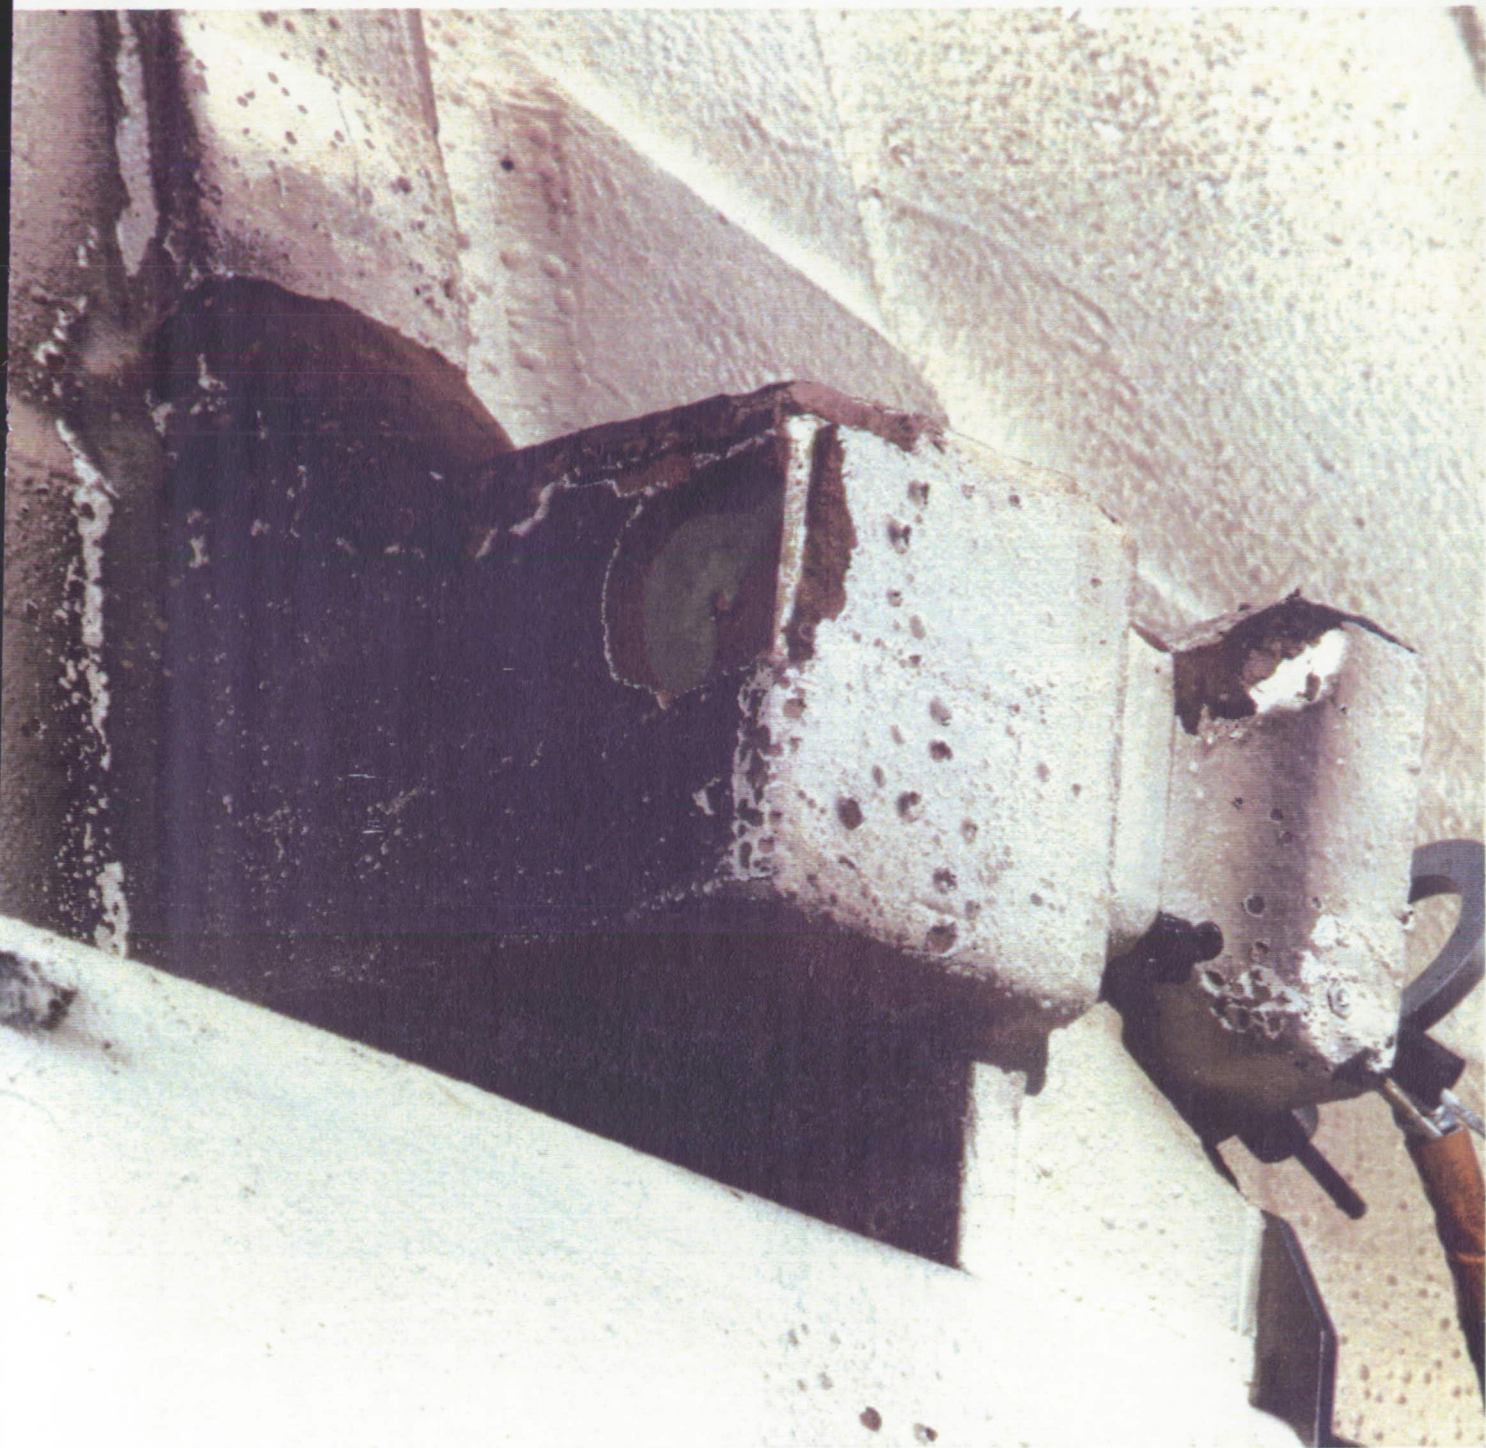
K5NA was missing from the aft face of the electrical
feed-through box

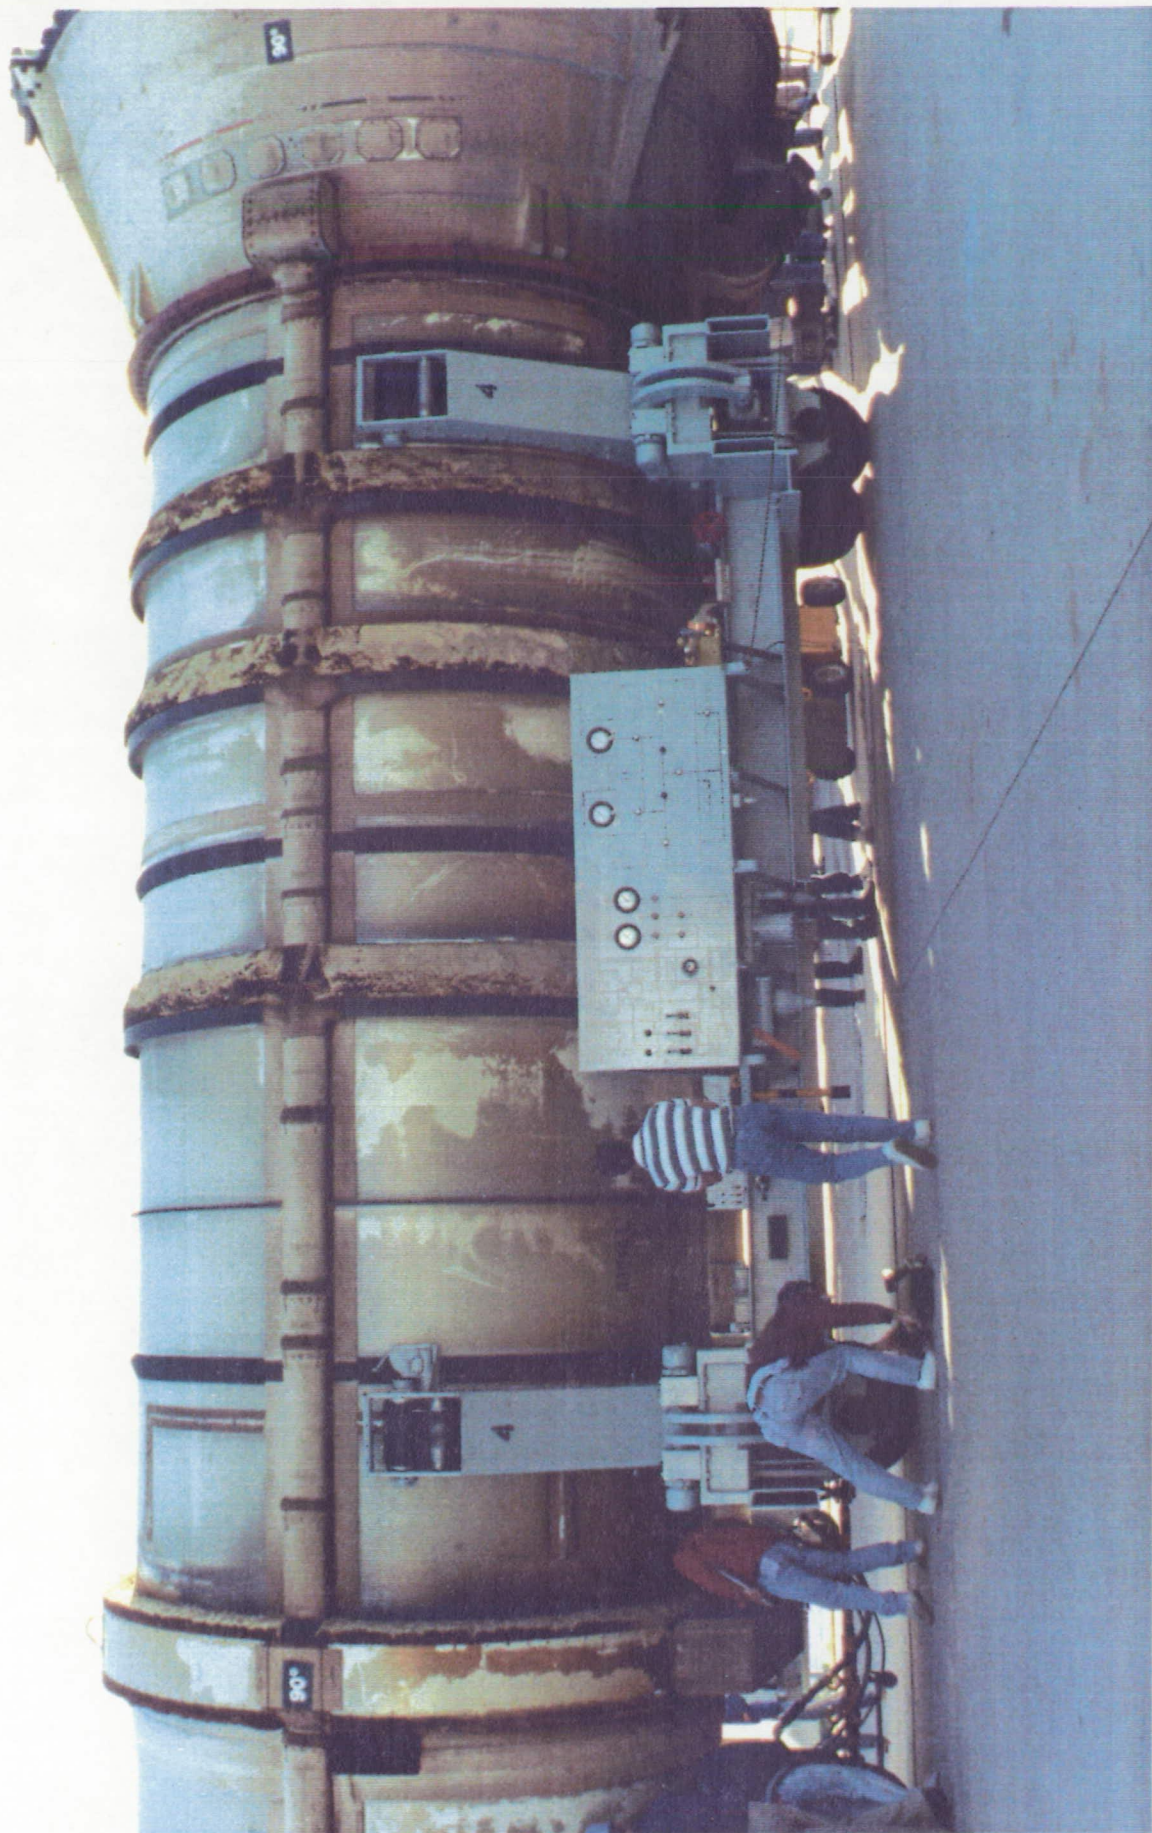
Post flight condition of the RH SRB aft booster. Stiffener rings were damaged by water impact, but there was no structural damage to the ETA ring or IEA.

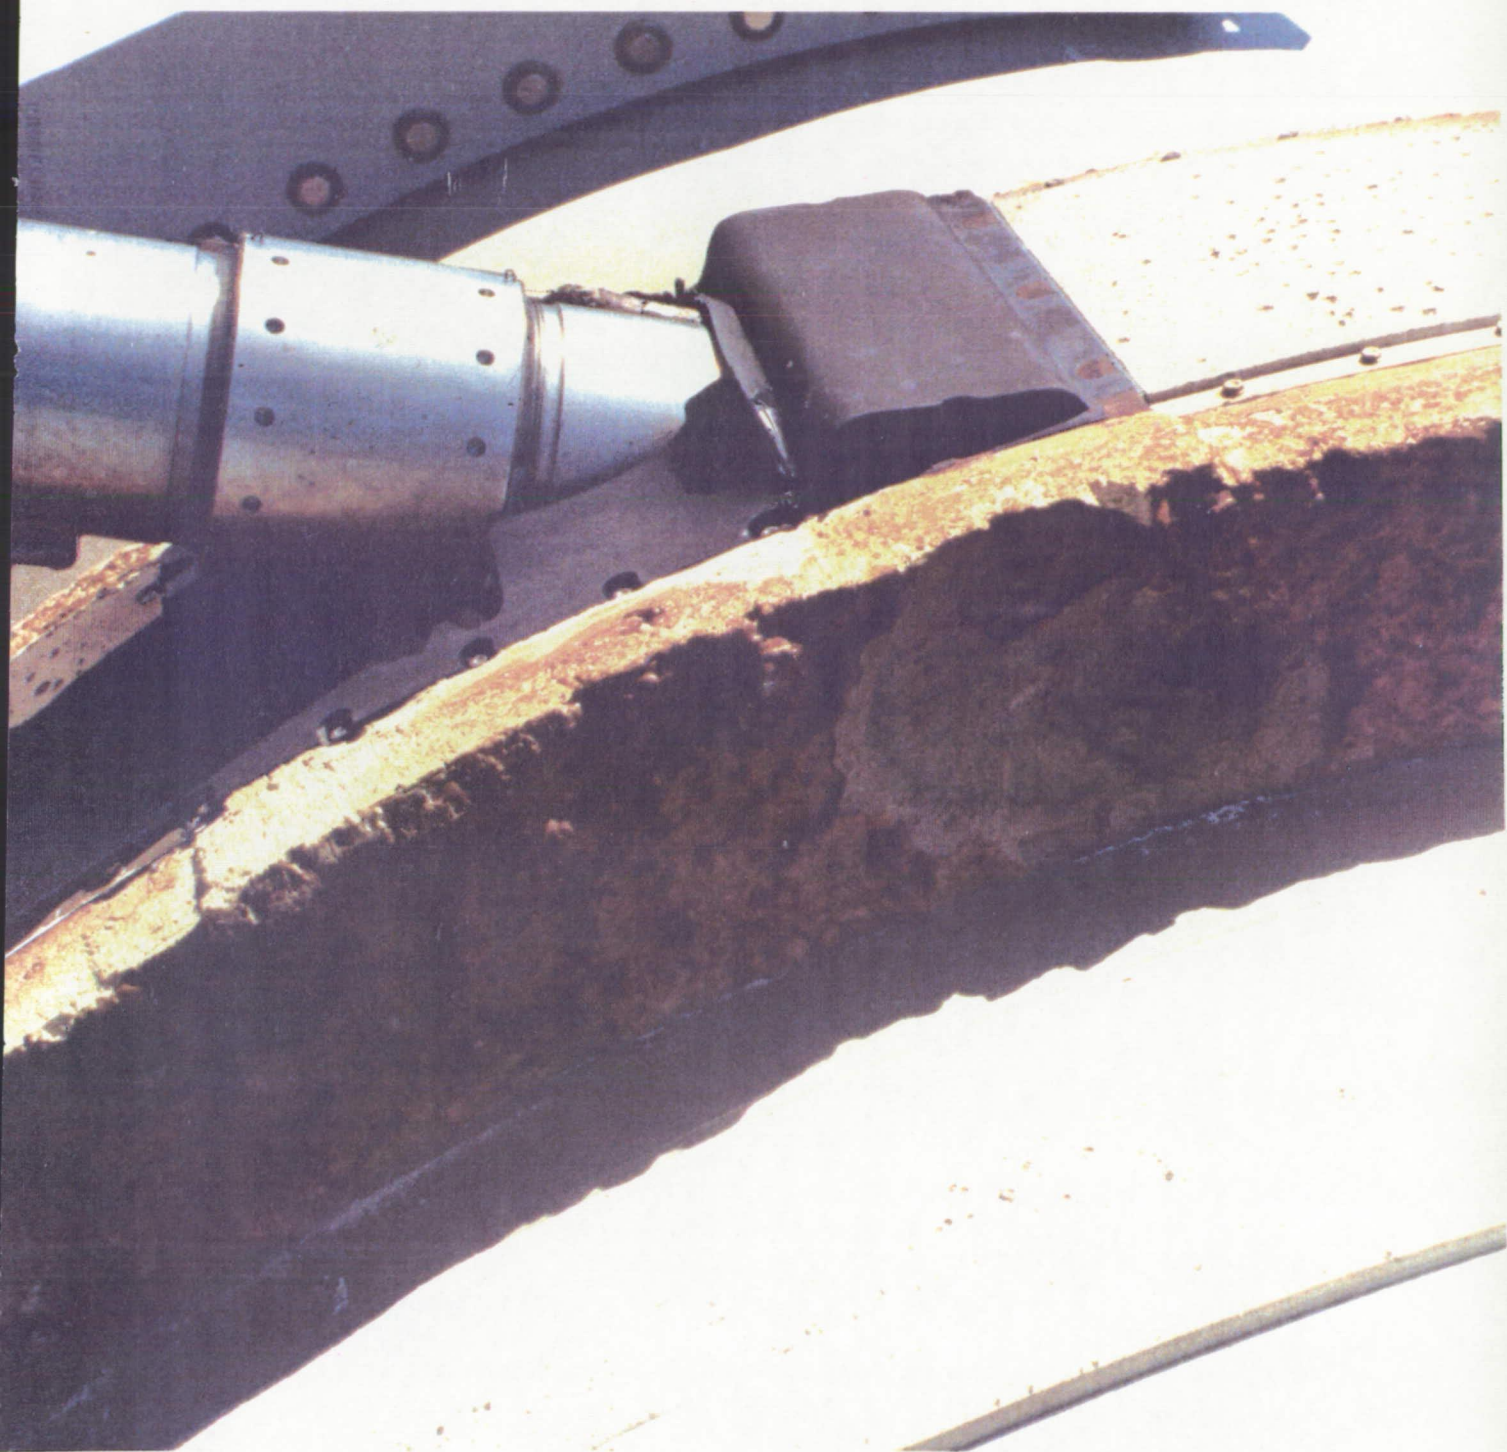
An IFA was taken against an 8-inch instafoam divot on the forward side of the ETA ring near the lower EB strut

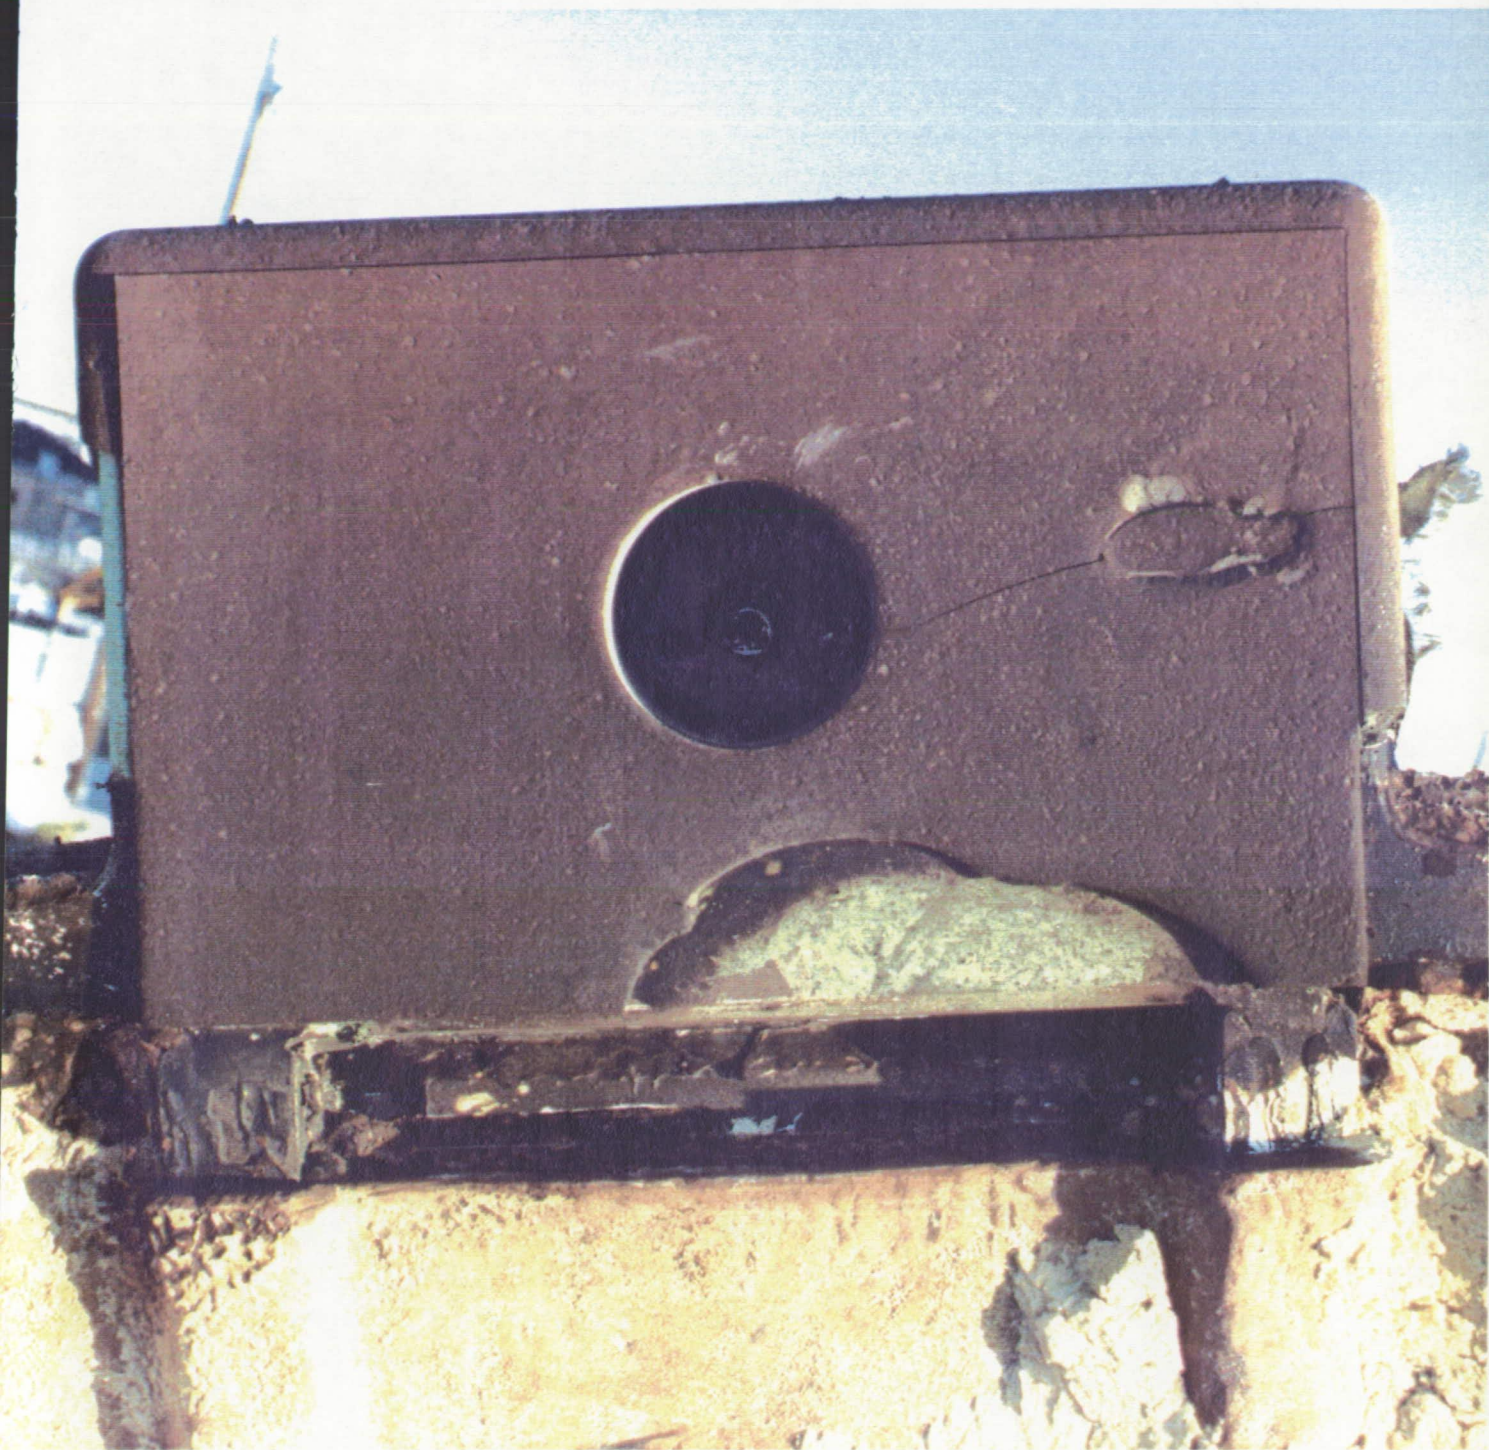
EPON shim material was missing from the aft skirt HDP #4 foot and the substrate was sooted. This condition coincided with the piece of EPON shim material that came loose at liftoff and was visible in the film review (film items E-7, 15, 27).

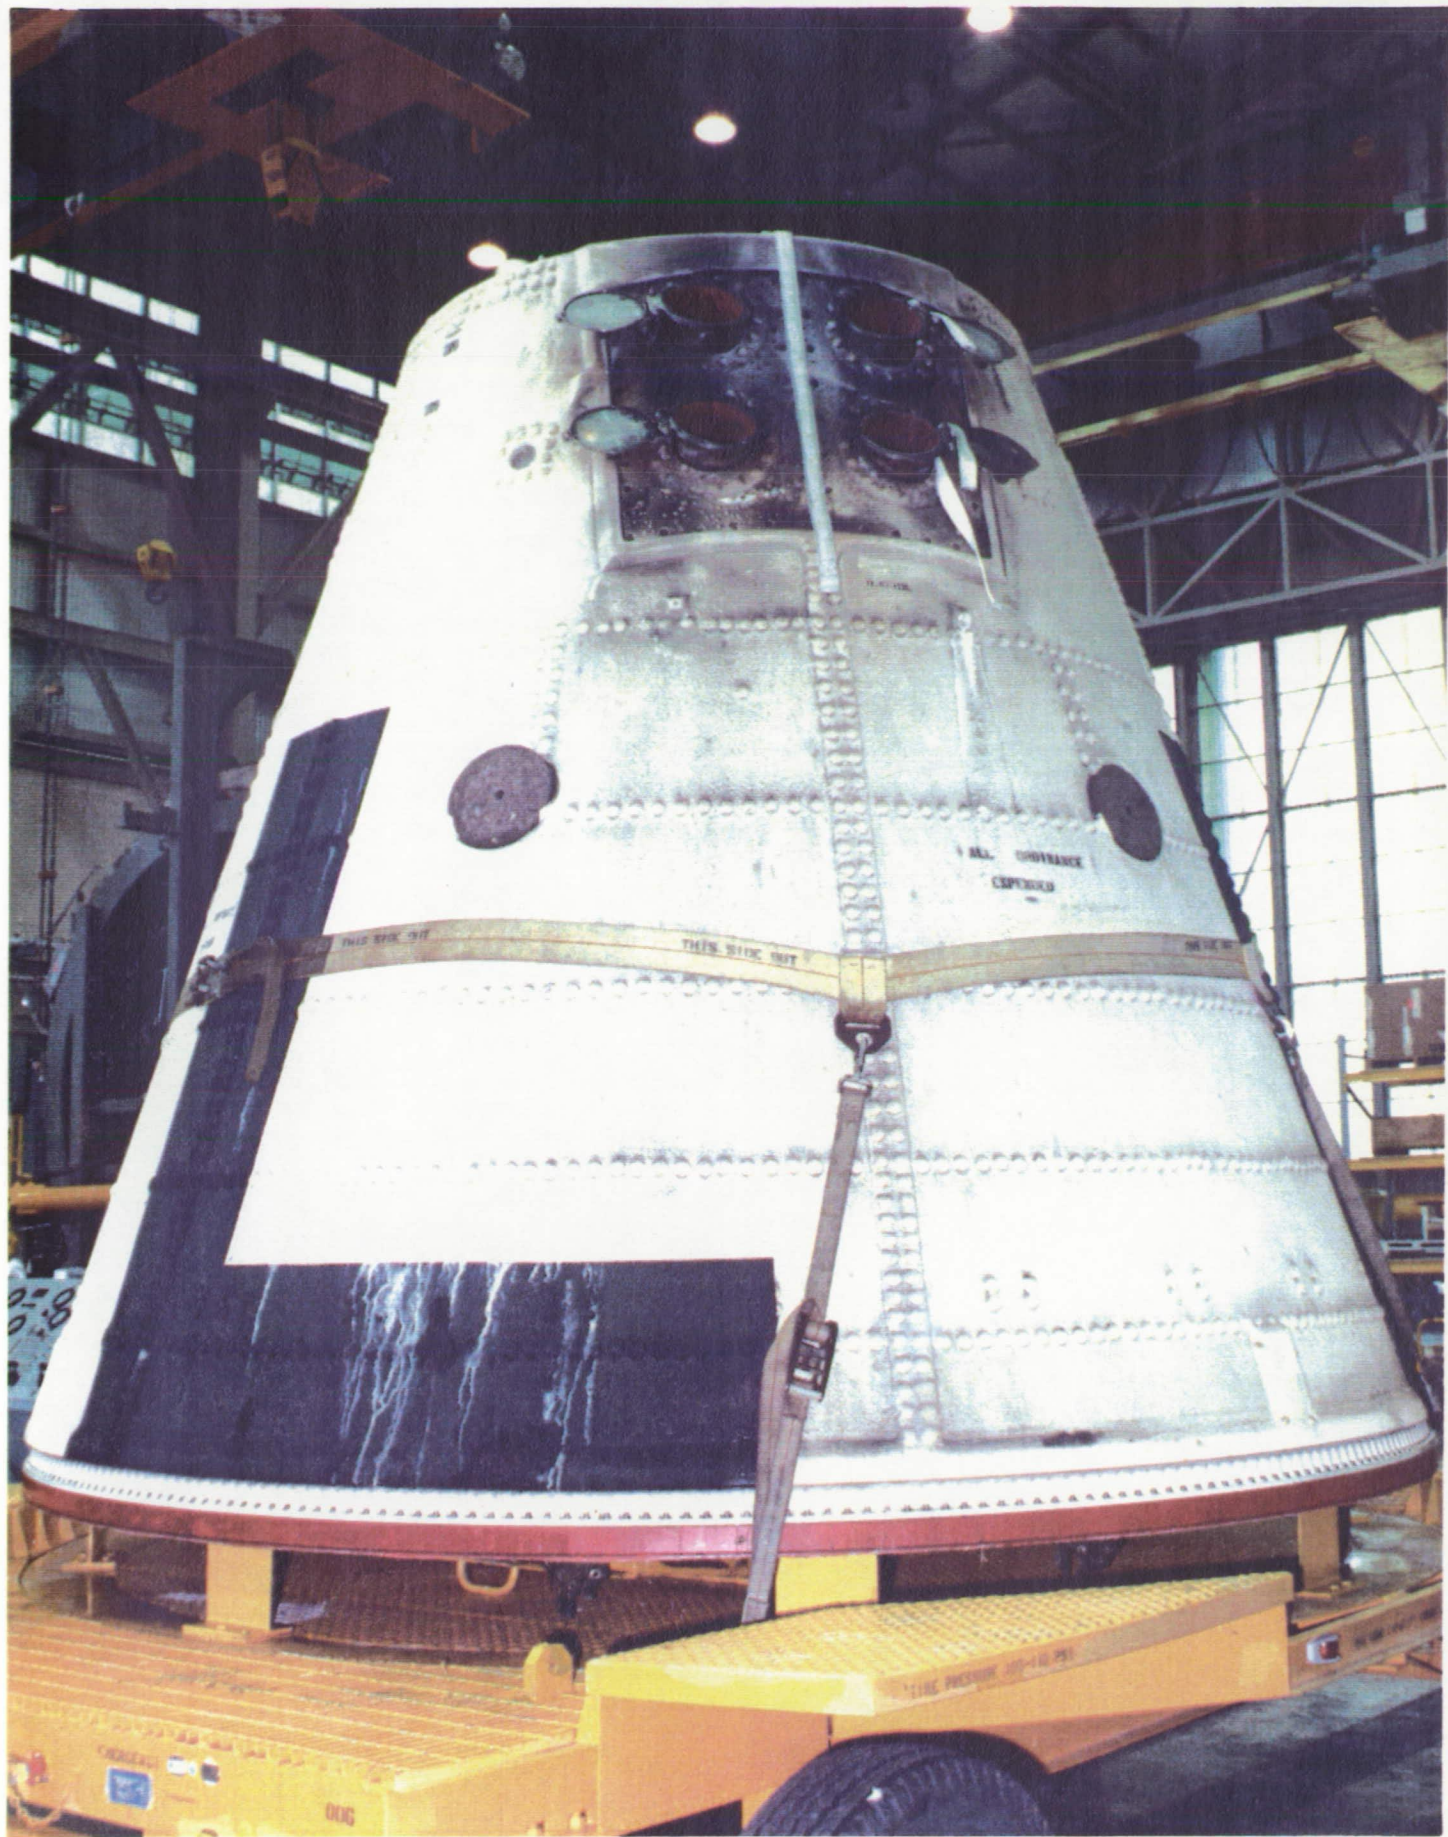
Post flight condition of LH SRB frustum. There were 54 MSA-2 debonds over fasteners, but no areas of missing TPS.

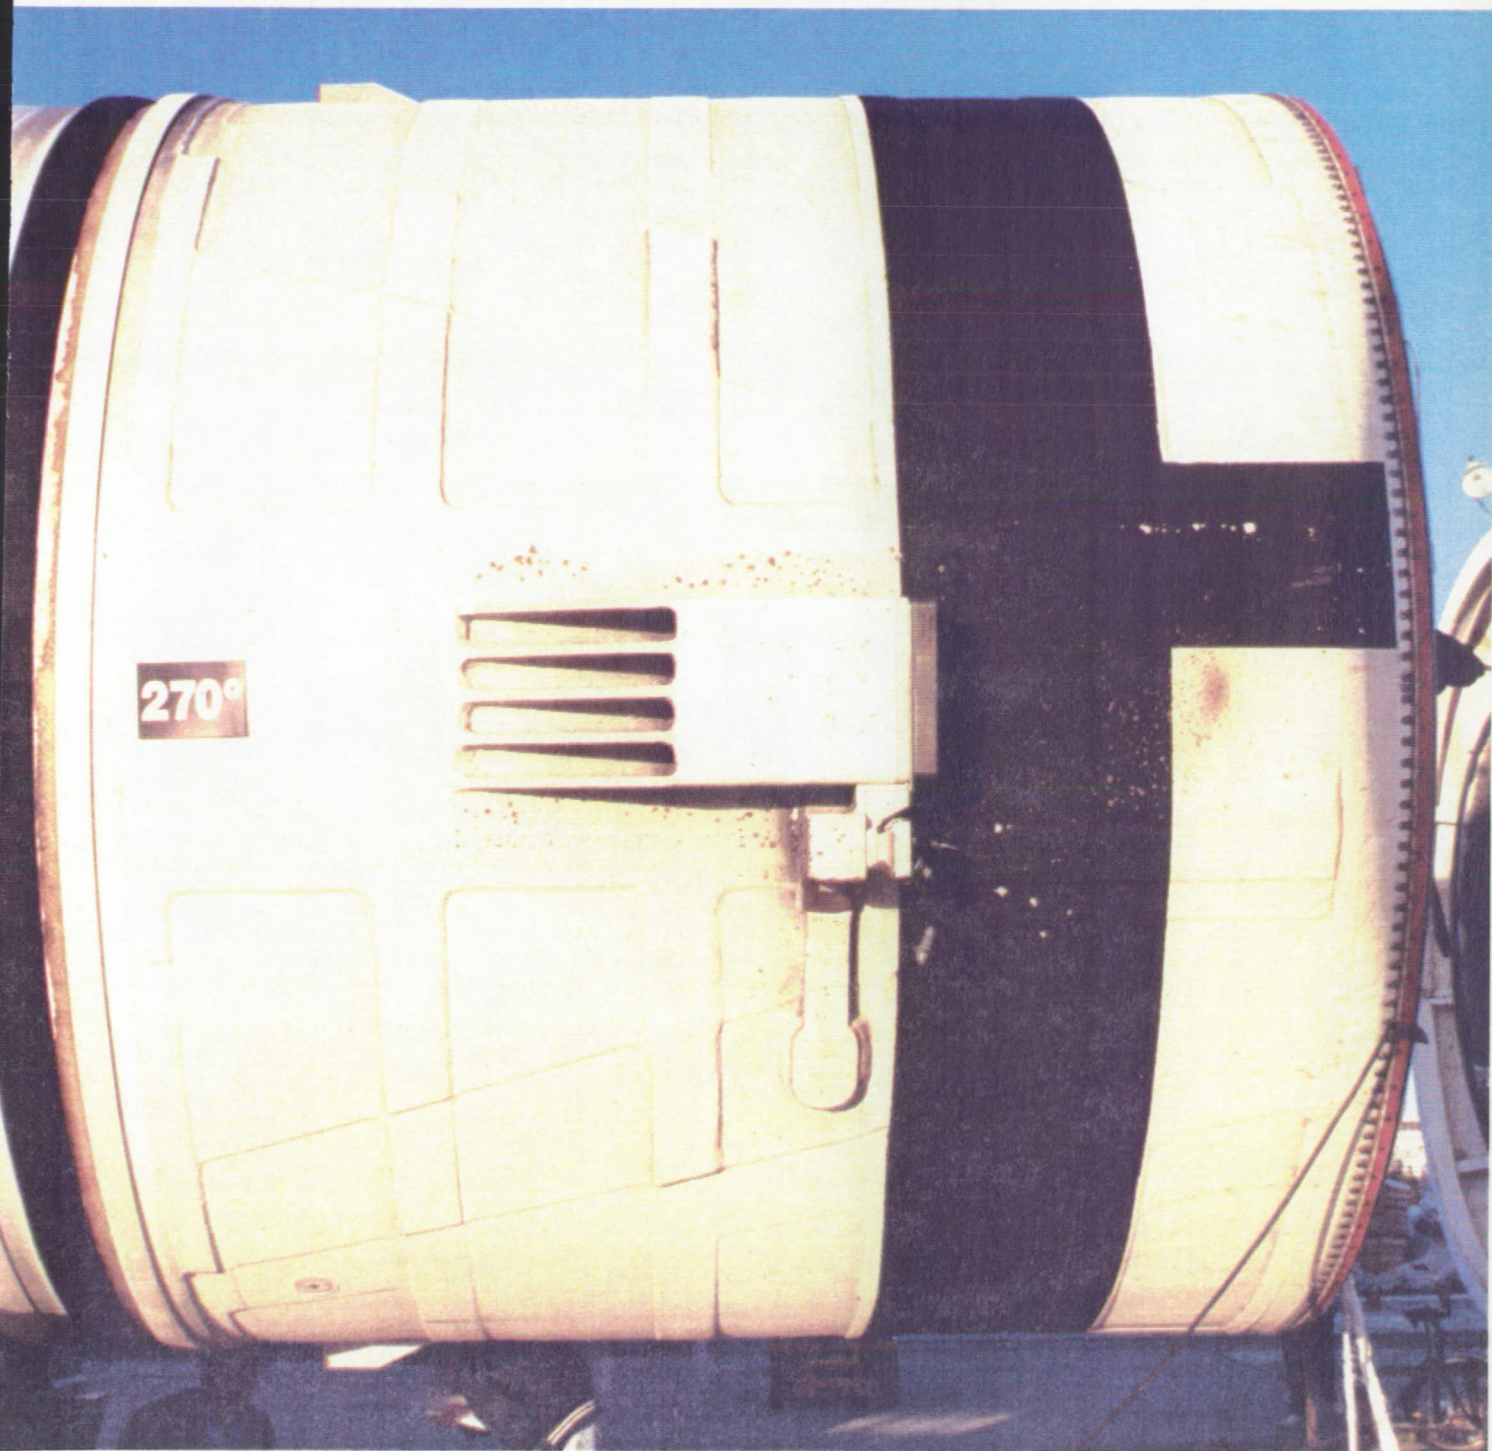
Post flight condition of LH forward skirt. There were no
MSA-2 debonds or areas of missing TPS.

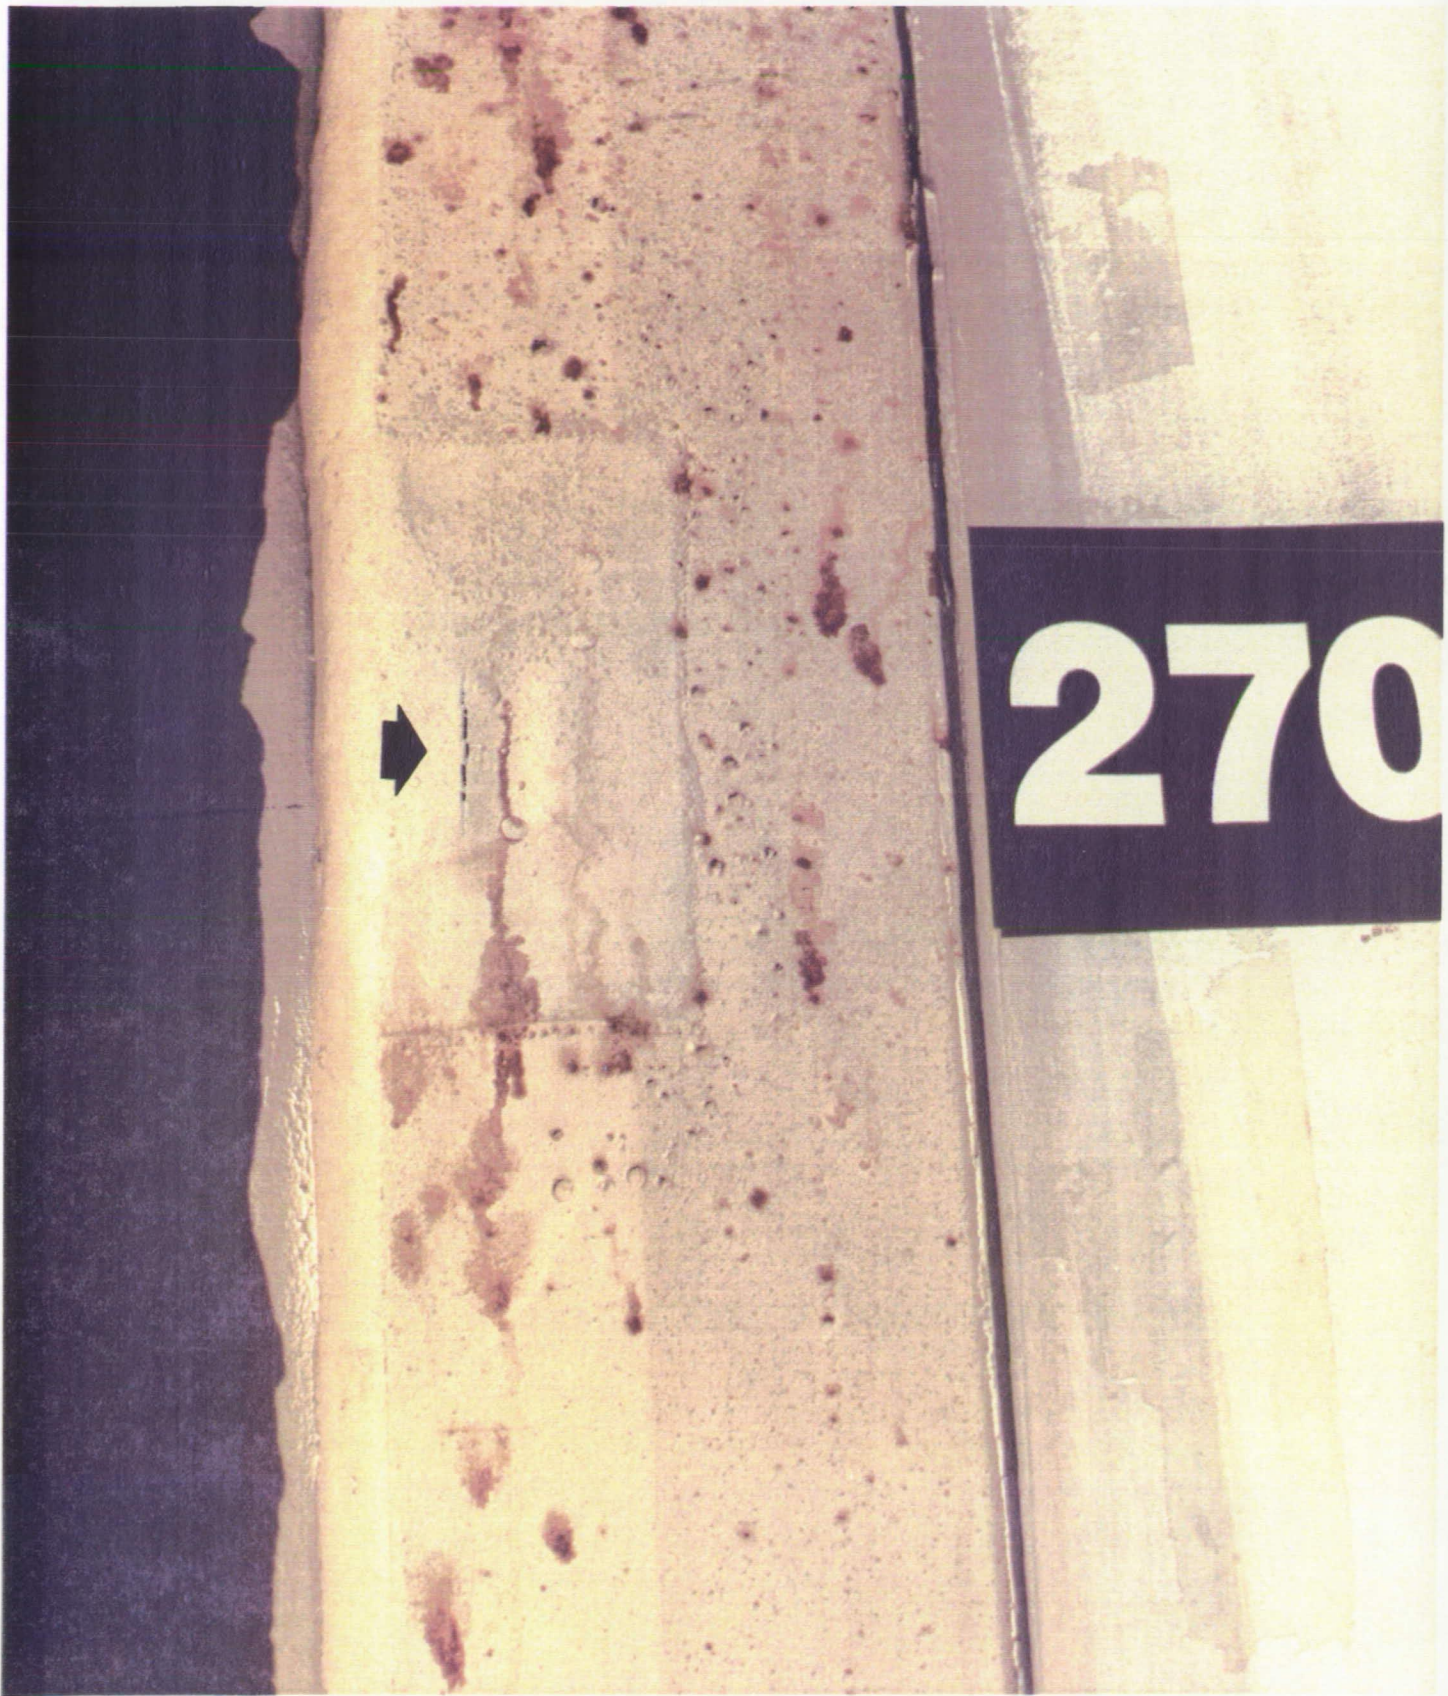
A 2.6-inch crack occurred in the K5NA closeout on the left
aft field joint trunnion

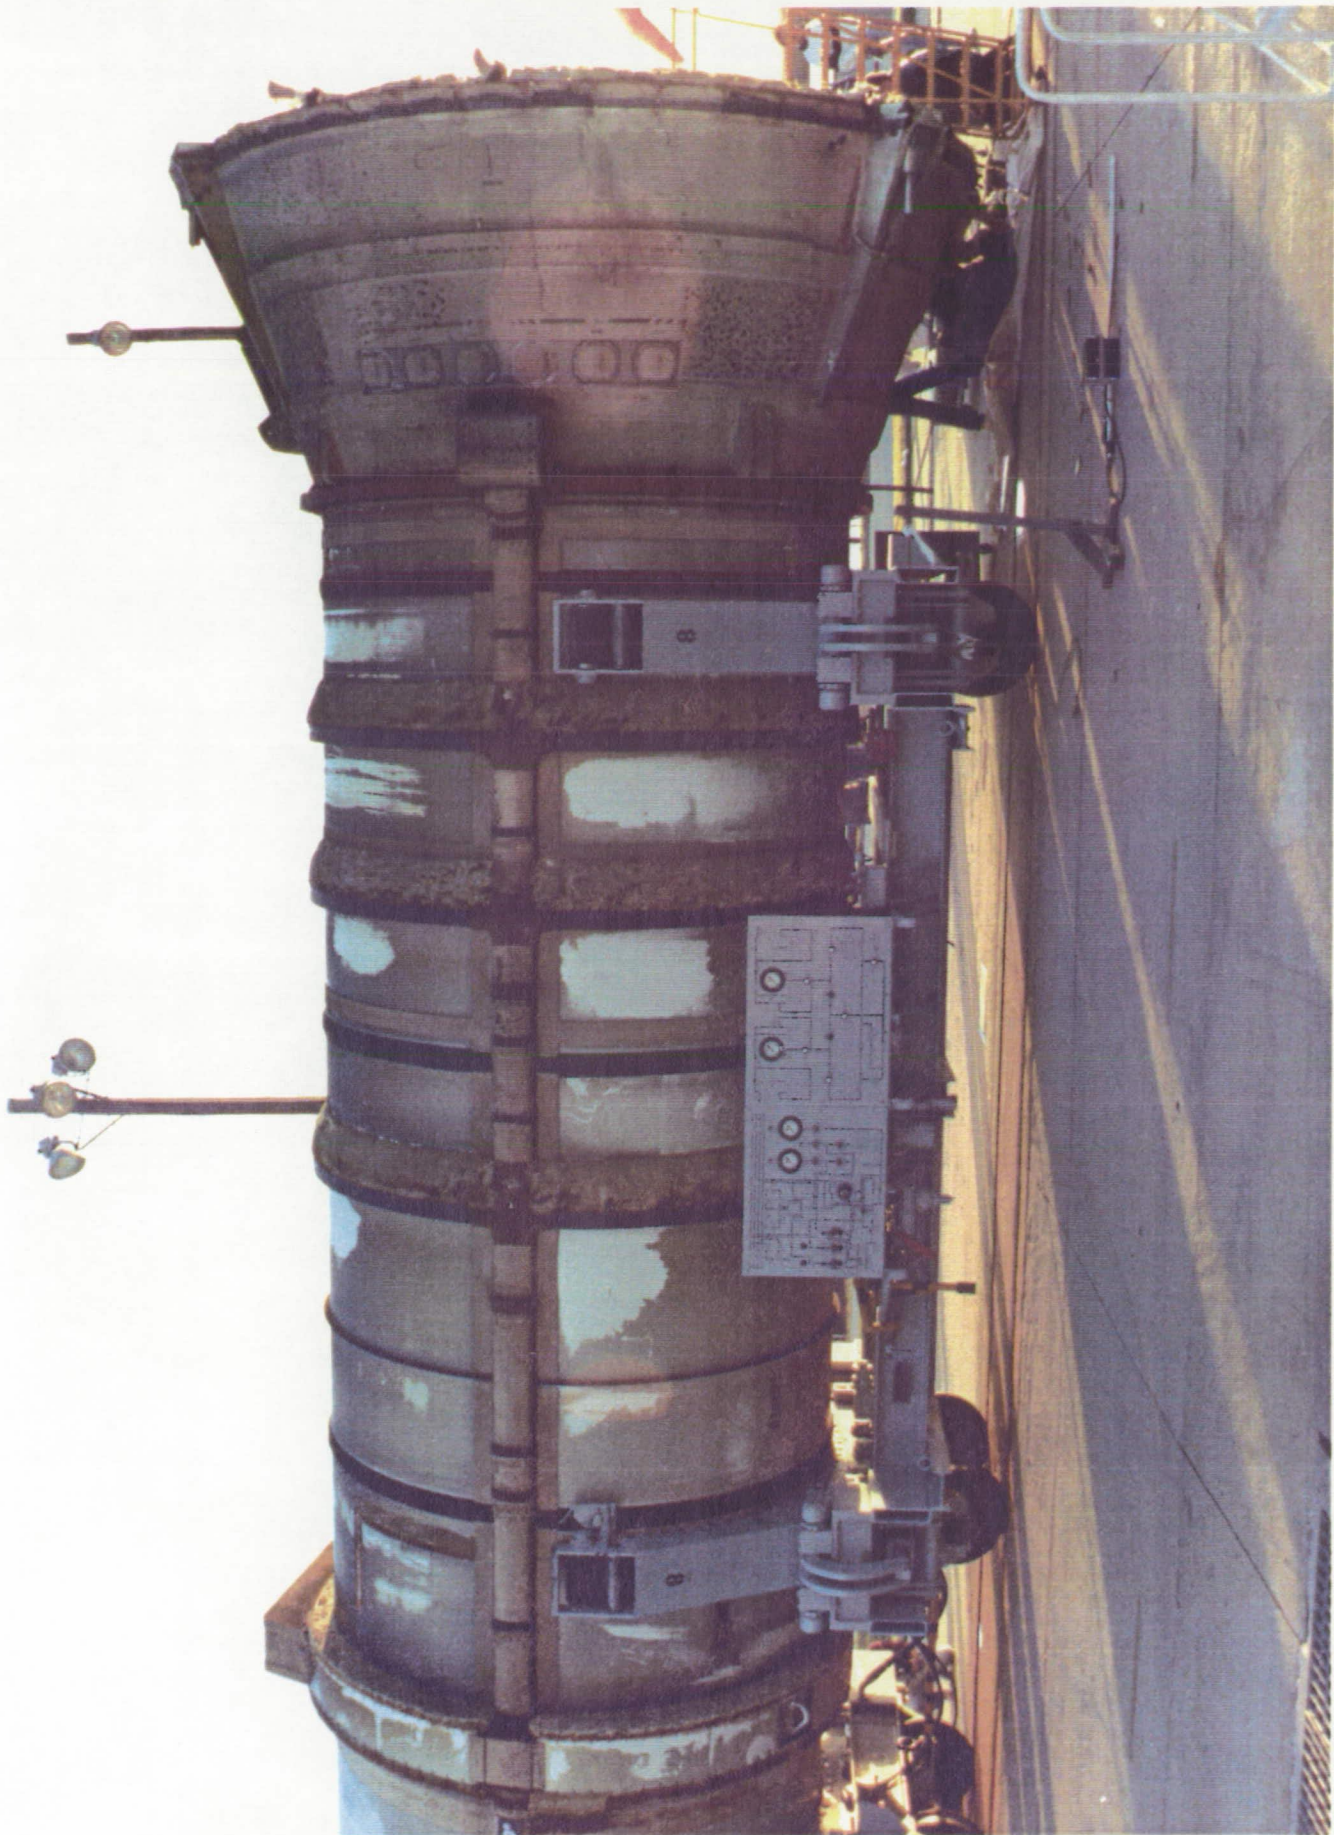
Post flight condition of the LH aft booster. There was no structural damage to the ETA ring or IEA.

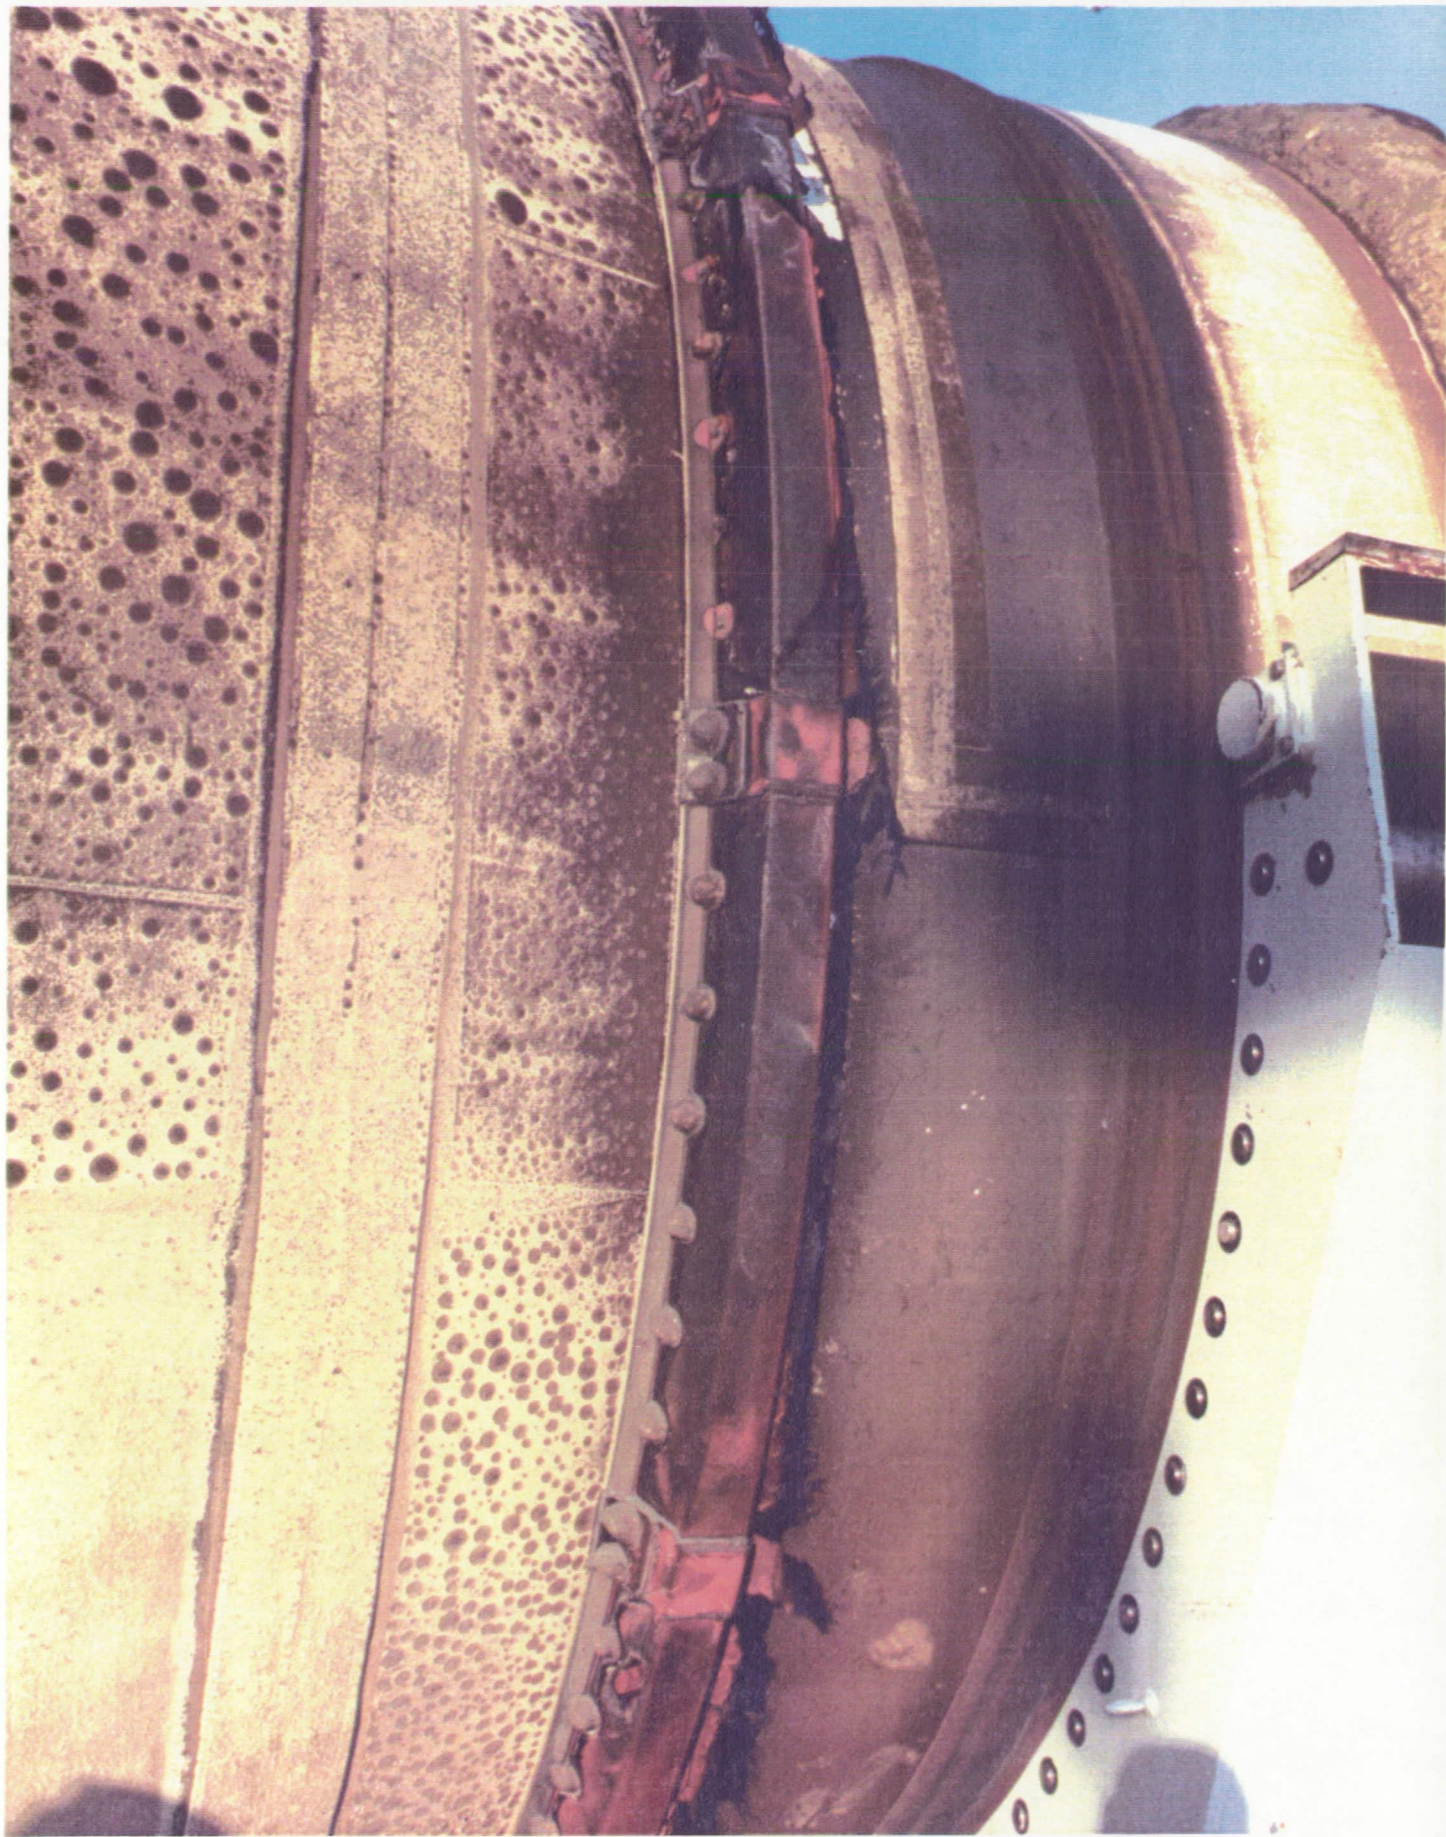
Some K5NA protective domes were missing from the aft side
of the phenolic kick ring prior to water impact
